U.S. Department
of Transportation
**Federal Aviation
Administration**

ADVISORY CIRCULAR 43-16A

AVIATION MAINTENANCE ALERTS

**ALERT
NUMBER
270**

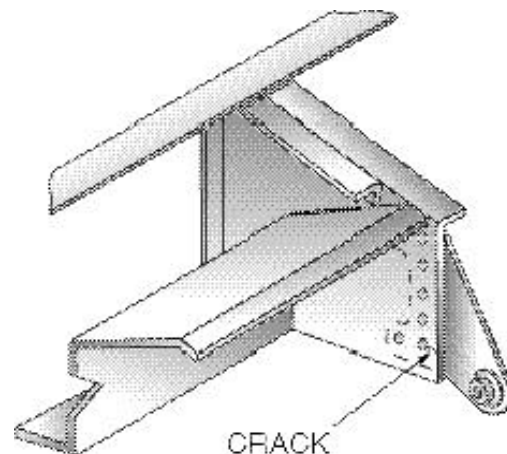
Beech; Model 76; Duchess; Wing Structure Defects; ATA 5712

During a 100-hour inspection, the technician found cracks associated with wing ribs at the left aileron location.

The cracks were located in the trailing edge of the wing ribs (P/N's 105-100010-1 and -2) adjacent to the left inboard and outboard aileron hinge bearing attachment brackets (P/N 105-100011-51). (Refer to the following illustration.) Both cracks began at the aft edge of each rib and migrated forward to the lower attachment rivet.

This defect presents a hazard to flight safety and, if not detected and corrected, may culminate in separation of the aileron.

The submitter repaired this damage by fabricating and installing doublers for each rib. He also reported he has maintained nine Beechcraft Duchess' over the past 6 years, and these two repairs represent the 23rd and 24th repairs of this nature. Further, he stated the cracks seem to develop after approximately 2,500 hours of operation.

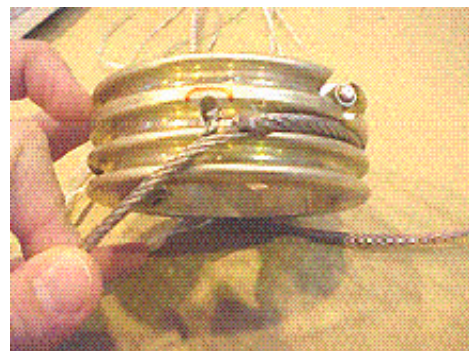
Cessna; Model 182S; Skylane; Flight Control Cable Damage; ATA 2710

While complying with Cessna Service Bulletin (SB) 00-27-02, dated August 14, 2000, the technician discovered severe damage to an aileron control cable.

SB 00-27-02 lists inspection criteria to determine proper pulley groove radius at the point where the interconnect cable is attached to the quadrant. Approximately half of the aileron cable (P/N 0510105-328) was severed. (Refer to the following illustration.) It appears the cable damage was generated where the cable contacted the pulley (P/N 1260112-1) groove. At this point, the pulley groove has a hole drilled to accommodate a pin used to attach the pulley to the aileron control tube assembly forward of the control yoke.

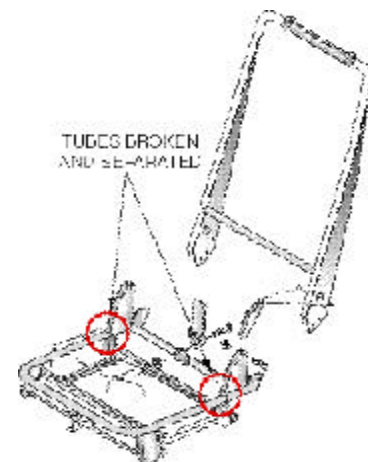
COMMANDER**Commander; Model 114; Seat Failure; ATA 2510**

A maintenance technician found the horizontal seat-frame tubes (P/N 49205-503) broken. (Refer to the following illustration.) Airworthiness Directive (AD) 85-03-04, Revision 2, concerns this subject and references Gulfstream Service Bulletin (SB) 114-21A, Revision 1.

It is interesting that AD 85-03-04, R2, is applicable to aircraft serial numbers 14,000 through 14,149 while SB 114-21A, R1, applies to aircraft serial numbers 14,000

through 14,540. This leaves 391 aircraft, including this particular aircraft, where AD 85-03-04, R2, does not apply. The manufacturer confirmed the seat-frame material and design is the same for all 540 aircraft. The FAA, Airplane Certification Office, ASW-100, issued AD 85-03-04, R2, and could not explain why these 391 aircraft were excluded.

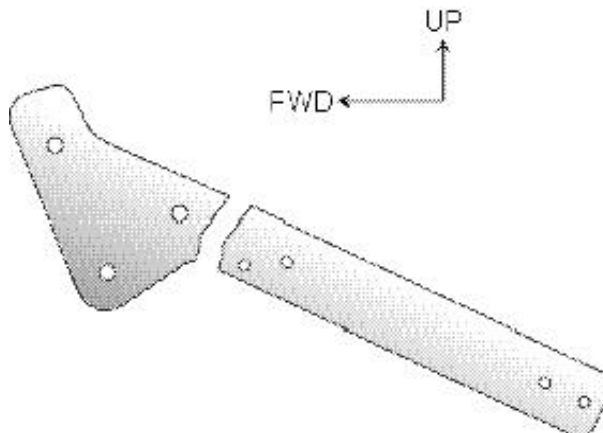
Mooney; Model M20J; Defective Wing Flap Hinge; ATA 5753

While conducting a preflight inspection, the pilot noticed the right wing flap had excessive travel and play with the flaps in the “down” position.

A technician removed the right wing flap faring and found the inboard hinge (P/N 210104) broken just below the hole for the aft attachment bolt. (Refer to the following illustration.) When he examined the broken metal, it appeared to be a “fresh” break.

The location and configuration of the flap hinge makes inspection difficult. However, the submitter recommended thoroughly inspecting this area at frequent intervals, especially on high-time aircraft.

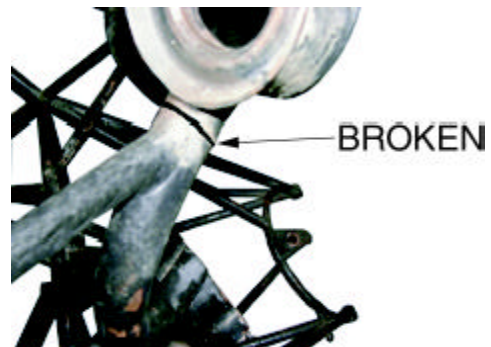
Piper; Model PA 28R-200; Arrow; Engine Mount Crack; ATA 7120

During a 100-hour inspection, the inspector discovered a crack on the engine mount structure.

The engine mount (P/N 67119-49) was cracked at the top left side. (Refer to the following illustration.) The submitter speculated, if not corrected, this defect could cause in-flight engine separation. Piper Service Letter (SL) 568 deals with this subject and provides inspection criteria and a repair scheme for defects found. In addition, a

similar article, involving a PA 28R-201 aircraft, appeared on page 10 of the September 2000 edition of this publication. The engine mount (P/N 67119-57) used on this aircraft is of the same design. The FAA Service Difficulty Reporting system data base contains 12 additional reports of defective engine mounts.

All operators are encouraged to obtain Piper SL 568 and comply with its instructions. Additionally, the submitter recommended closely inspecting the engine mount at 100-hour intervals.

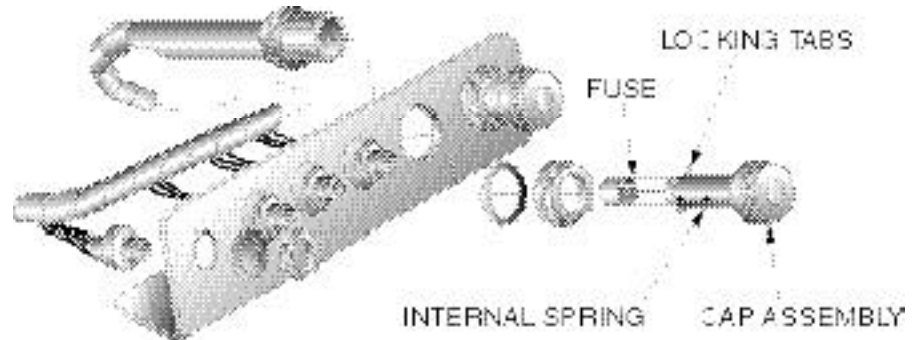
ROBINSON**Robinson; Model R-22; Mariner; Defective Fuse Holders; ATA 2400**

The submitter reported finding several defective electrical system fuse holders.

The fuse holder cap locking tabs were bent and broken, and the springs were corroded and stuck in the compressed position. Failure of a fuse holder will cause an interruption of electrical power and failure of the affected component. (Refer to the following illustration for an example.)

The submitter recommended the manufacturer construct the fuse holders of a more durable material and change the design to make them more structurally substantial.

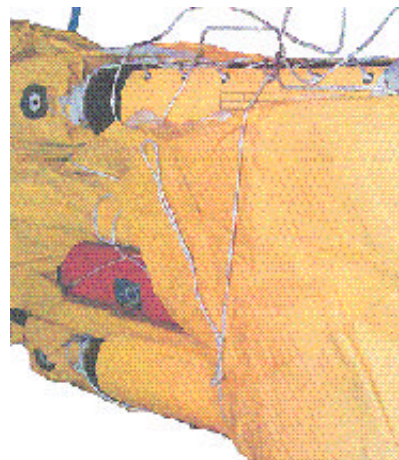
During an initial inspection, the technician discovered a “temporary packing tie” was left on the liferaft after it was packed. (Refer to the following illustration.) The “temporary packing tie” is used as an aid for installing the liferaft into the container after manufacture and inspections. The presence of this “temporary packing tie” would prevent deployment of the liferaft.

This liferaft was manufactured in November 1998, and the submitter speculated the “temporary packing tie” might have been overlooked at that time. It is also possible the “temporary packing tie” may have been overlooked at another time. All operators should be aware of this possibility and take appropriate action.
